REPORT OF ACCELERATION TEST

PAN SUBSYSTEM, UNIT NO. 2

Project 9040

JANUARY 15, 1963

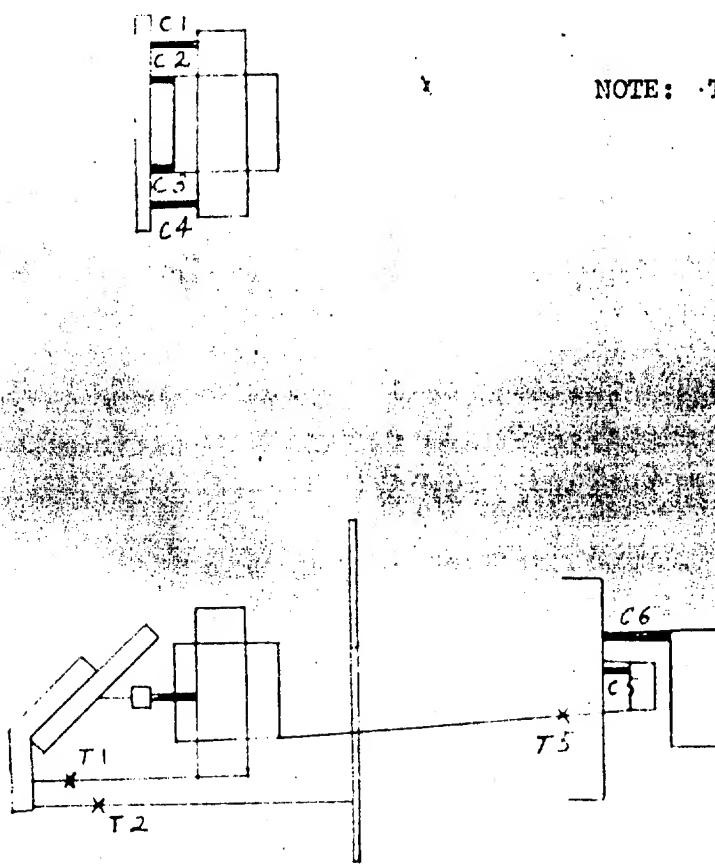
CONNECTOR NO.	LOCATION	MAX. DEFL IN
T ₁	Reflector to Scan Housing	.03
T ₂	Reflector to MT Flange	.03
T ₃	Test Fixture-Center to Base (Y-)	0
T ₄	Test Fixture-Center to Base (Y+)	.03
T ₅	Cell to Platen	0 to 1/6
C ₁	Bridge to Trunnion Fitting (Y-)	.035
C ₂	Cell to Trunnion Fitting (Y-)	.015
C ₃	Cell to Trunnion Fitting (Y+)	.022
C ₄	Bridge to Trunnion Fitting (Y+)	.035
C ₅	Platen Center to Inner Tube	.003
C ₆	Transport to Inner Tube	.003

* Connector T₅ was not accessible for accurate measurement.

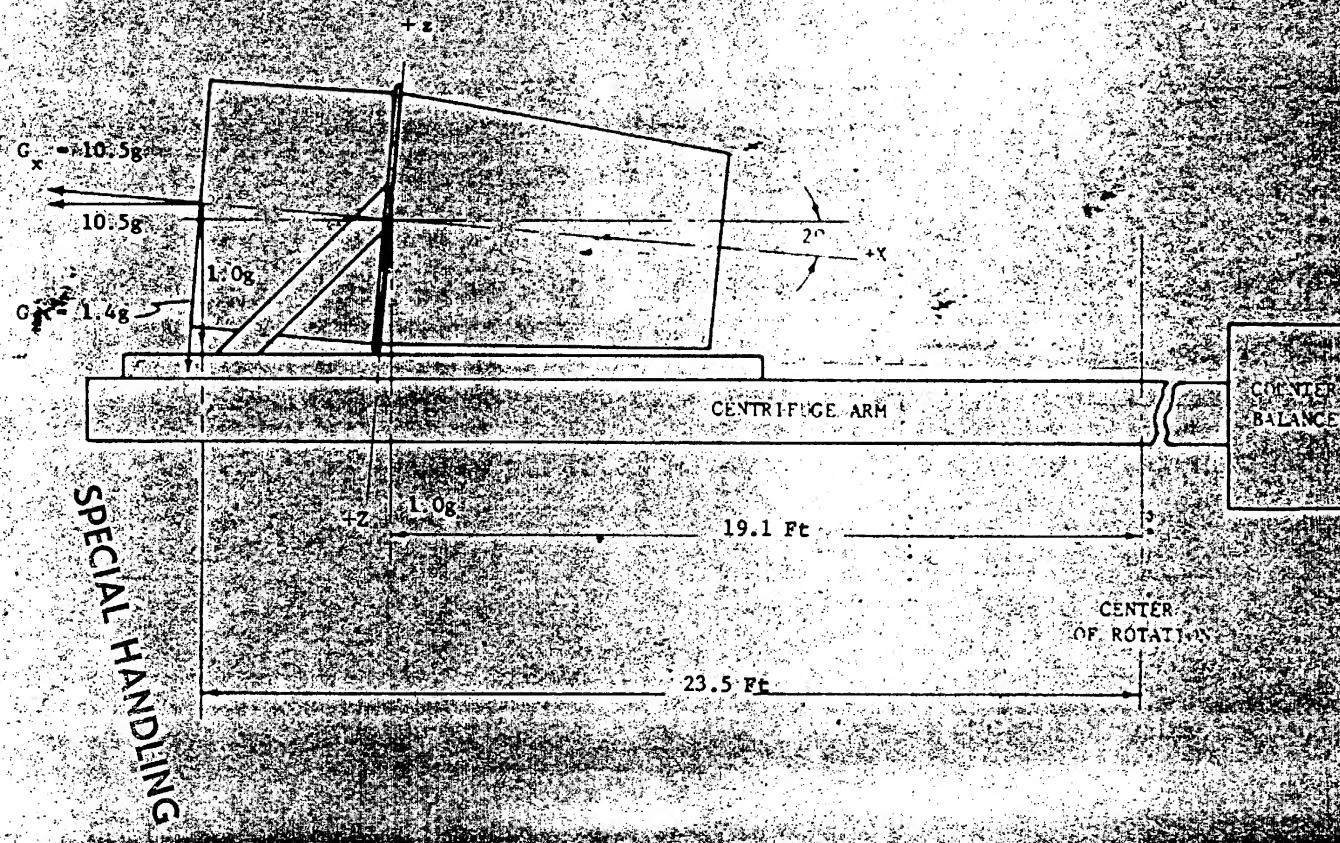
Figure 2. Acceleration Test Set-up;

The test fixture, Serial No. 52236, was designed to hold the subsystem at a 2° angle as shown in Figure 2. With the unit at this angle, the combined force in the + Z direction is 1.4 g for a force in the - X direction of 10.5 g.

The test fixture and subsystem were bolted to the MIT Centrifuge as shown in Figures 2 and 3. Power was applied from portable power supplies through the centrifuge slip rings to interface connector J101. Circuit breakers T1 through T5 were wired through the slip rings to a signal box located in the control room. The fabric shrouds were removed and deflection gages T1 through T5 were adjusted so that 1/4 inch relative motion across them would break the circuit causing a lamp in the signal box to be extinguished. Initial readings were taken on all deflection gages and recorded. The shrouds were strapped in position again.
